A Validated Test Methodology to Evaluate Radial Ply Tire Road Hazard Impact Failures

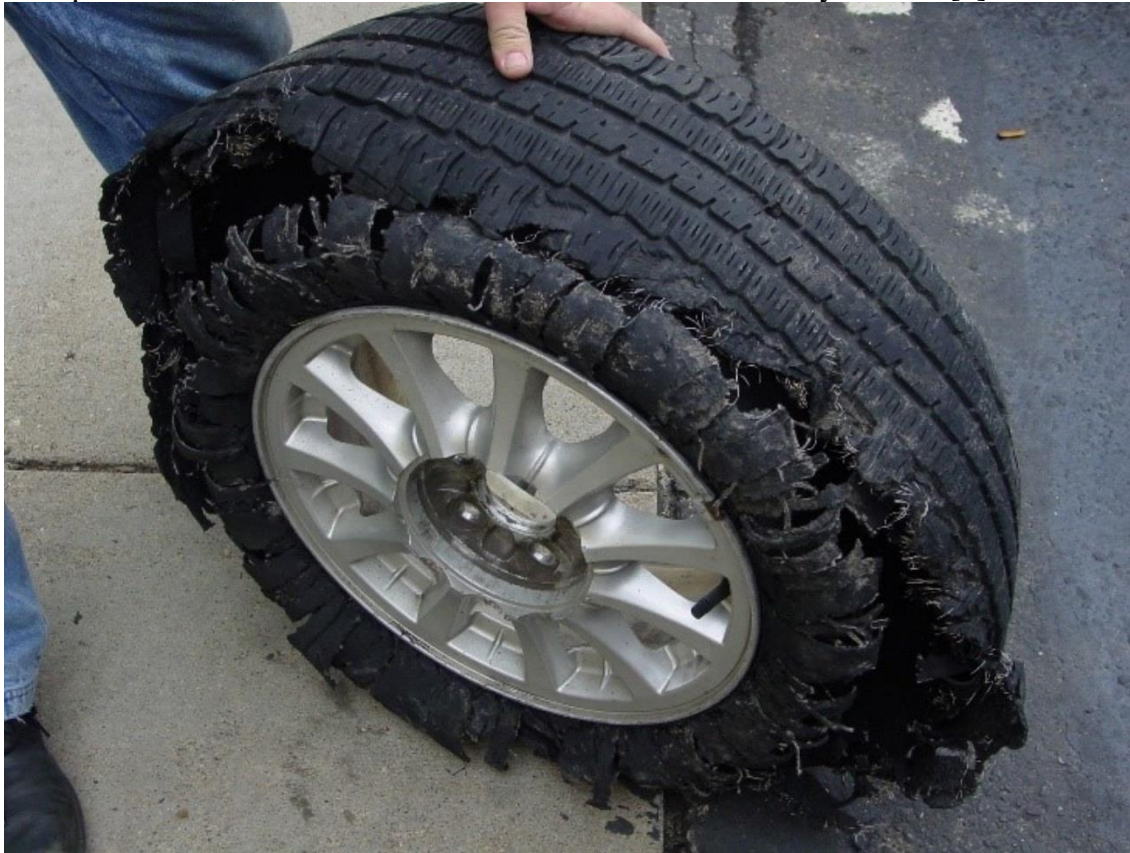
Figure 1 - Tire damage caused by grossly underinflated operation. The sidewalls exhibit multiple fractures, and the shoulders have been circumferentially severed [4].

If the puncture goes undetected the tire may continue in service at reduced inflation pressure. Should the pressure be sufficiently low for the load being carried – because of a puncture or for other reasons - excessive deflection may lead to structural damage to the tire. Such damage may be evidenced by fracturing or discoloration of the inner liner and sidewall [1], and potentially permanent distortion of the bead areas at the radii at which they deflect over the rim flange [2], although the published literature on the strength of the latter is equivocal [3]. Runflat damage alone may render the tire unsuitable for further use; if it continues in service much more substantial (and potentially catastrophic) structural damage may ensue, including (in the case of steel belted radial ply tires) complete detachment of the tread and steel belt package from the body ply or sidewalls as seen below.

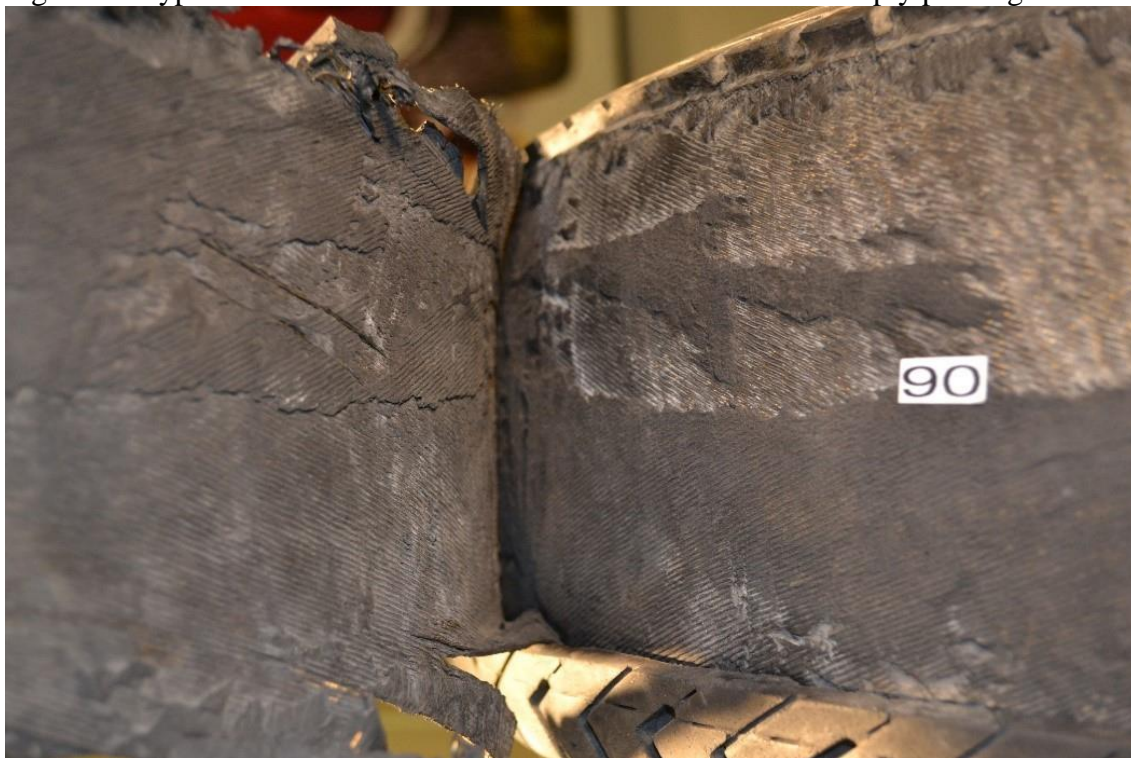
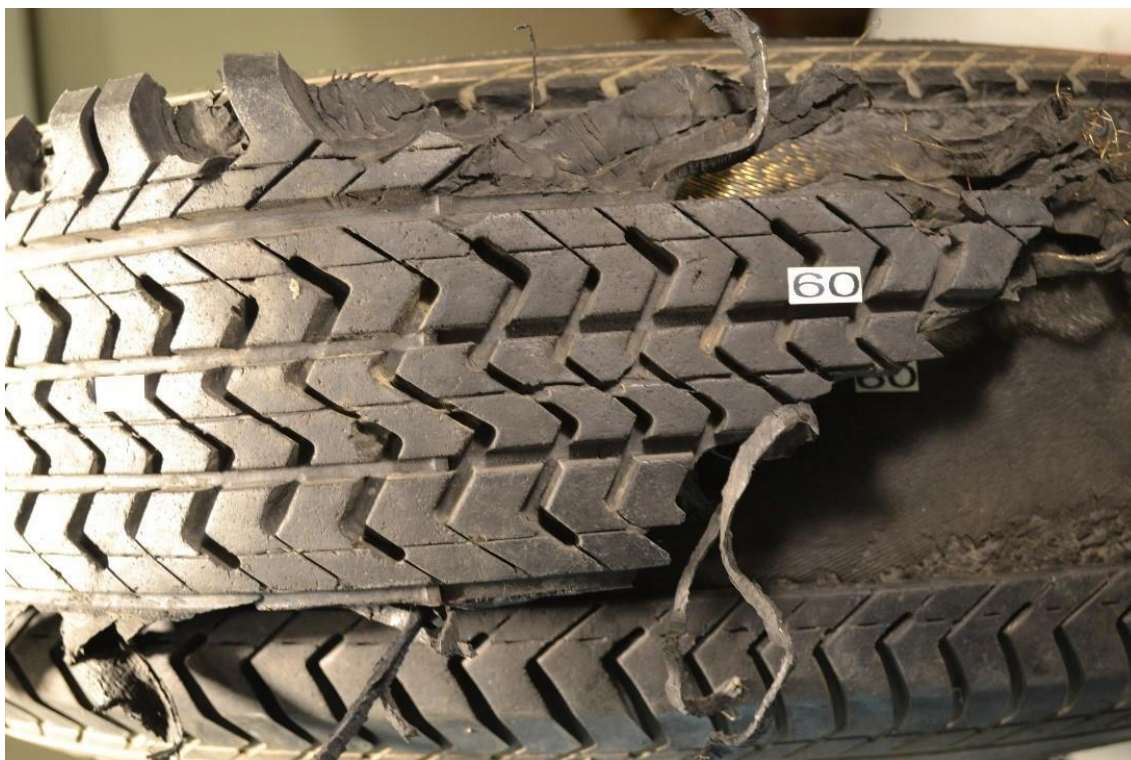
Figure 2 - Typical tread and belt detachment of a steel belted radial ply passenger car tire [6]

Sudden detachment of portions of the tread and belt package is another (if less common) unforeseeable failure mode of steel-belted radial ply tires. It is important that the causes are understood. Various organizations have published information indicating that in-service impacts with “road hazards” may cause tire disablements, including sudden tread and belt detachments that occur well after the impact itself, *having left no externally visible evidence of the event* [5]. The purpose of the present work is to analyze the basic physics of tire/road hazard impacts, review the literature that considers this phenomenon, to evaluate (in light of theoretical and real-world tire service conditions) the applicability of the test methodologies employed therein, and to propose an alternative test methodology.

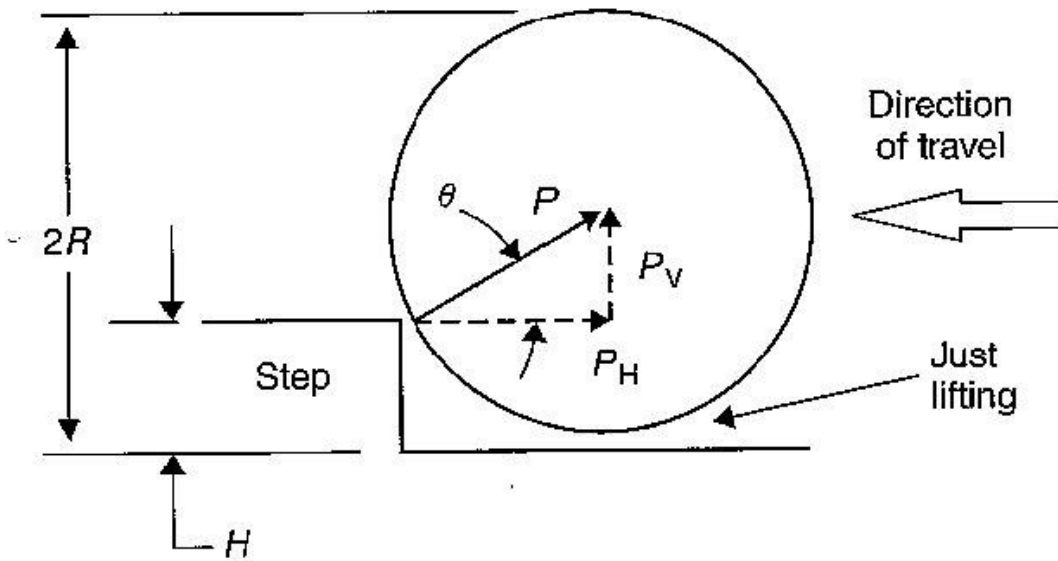
Figure 4 – Free body diagram of a wheel striking a step [14]

In Figure 4, P_V is the static vertical wheel load, H the height of the step and R the tire radius.

The resultant force P (acting through the centre of wheel rotation) can be broken into its component parts as follows:

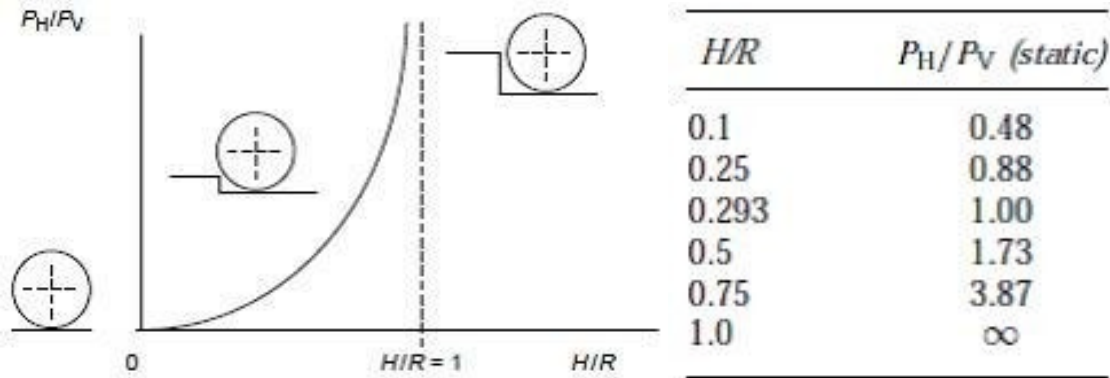
Figure 5 – Relationship between step height H, tire radius R and static horizontal force [15]

As can be seen in Figure 5, for a given tire diameter, horizontal forces (relative to the vertical wheel load) increase rapidly with step height:

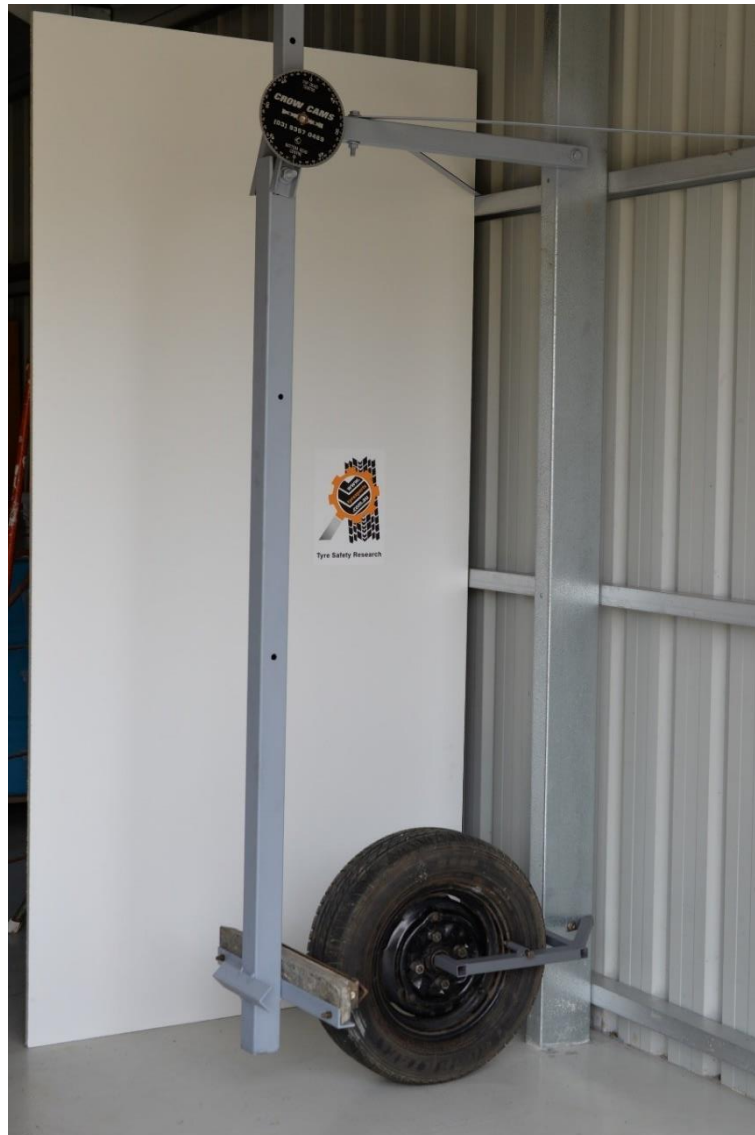
Figure 6 – Simple impact pendulum, dimensionally equivalent to an SAE J1981 impact machine

In order to demonstrate the tire impact loading differences between this test methodology and those experienced by rolling tires mounted on vehicles in service, a simplified pendulum mechanism, dimensionally equivalent to an SAEJ1981 impact test machine, was constructed (see Figure 6).

A GCDC-X16-1D 3-axis accelerometer was used to measure the direction and magnitude of forces imparted on a rigidly-mounted wheel and tire (175/70R13 @ 207kPa) assembly that was subjected to an impact by a 26.3kg striker blade released from 90 degrees. The following table provides the results:

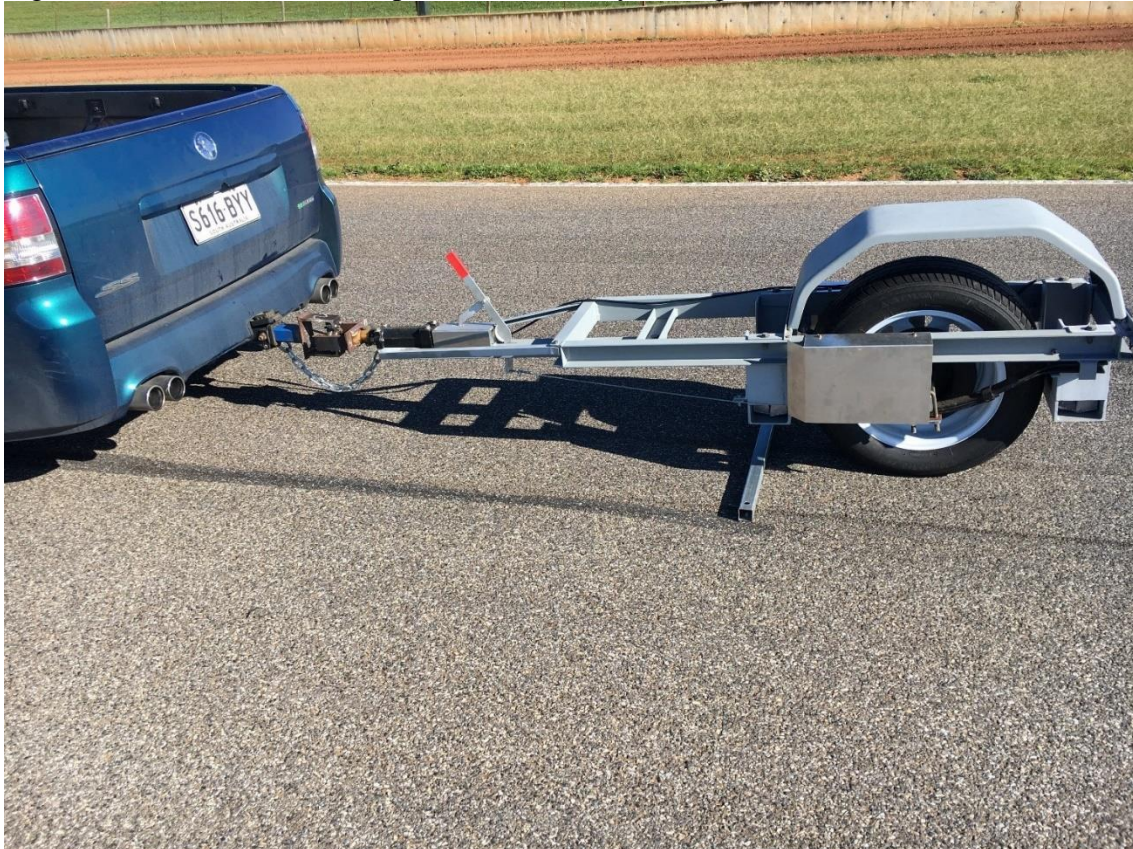
Figure 7 – The on-road tire impact and durability test rig (PSR/LVR version)

A single wheel trailer facilitates impacts with objects while the towing vehicle wheels remain unaffected. Dissipation of impact forces replicates that of a complete vehicle – i.e. through the tire and suspension system, and through vertical displacement of the vehicle. Vertical load and wheel alignment can be adjusted to replicate the required condition. Accelerations in three planes can be continuously monitored and logged, as can inflation pressure, speed,
